POST-GLASS BREAKAGE PERFORMANCE OF LAMINATED SAFETY GLASS

This bulletin therefore outlines the various tests that are used to analyze the impact resistance and post-glass breakage performance of laminated glass.

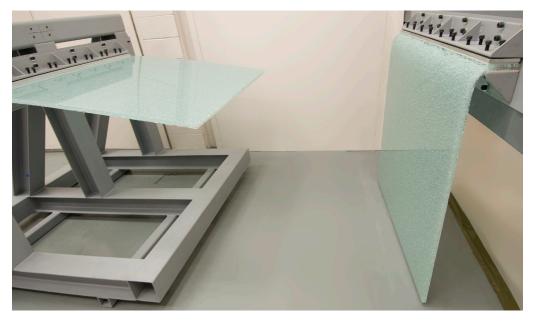
SentryGlas[®] vs PVB – post-glass breakage

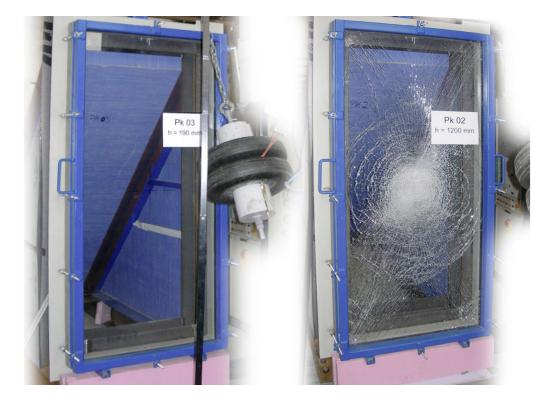
IMPACT TEST

In terms of impact resistance, the benefits of SentryGlas[®] ionoplast interlayer compared to PVB are shown in the figure below.

Impact test EN 12600 by University of Applied Science, Munich, Germany, 2009.

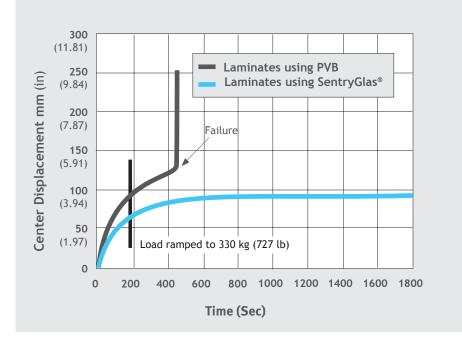
POST-GLASS BREAKAGE PERFORMANCE

Results from comparative tests conducted by Kuraray and independent research institutes demonstrate that the post-breakage performance of laminates with SentryGlas® ionoplast interlayer are superior to those with PVB. This is due to the unique properties (polymer modulus and adhesion) of the SentryGlas® interlayer. During creep load tests, both laminates were loaded with 330 kg (727 lb) sandbags. The glass was then fractured with the load remaining constant. The deformation (center displacement) was then recorded over time.

From the table above, it can be seen that deformation of the PVB laminate was much greater than the laminates using SentryGlas[®].

Furthermore, the PVB laminate tore after approximately 7 minutes, whereas the laminate with SentryGlas[®] remained intact.

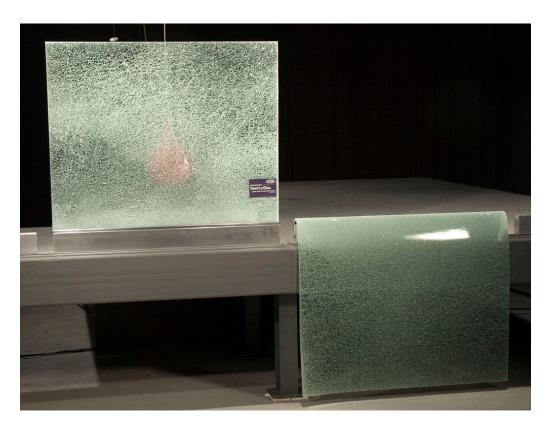
In further tests at Kuraray, cantilevered glass balustrades / railings were tested for their post-glass breakage performance. These impact tests simulate potential human loading. The tests involved multiple high strength glass types (all were fully tempered with open, polished edges). This included laminates with PVB interlayer, SentryGlas[®] interlayers, monolithic fully tempered glass, and applied PET film.

The tests involved the use of cantilevered glass balustrades manufactured by R.B. Wagner Industries, which were impact tested using a 45 kg (100 lb) shot bag dropped from various heights.

- The test results showed that the laminates with SentryGlas[®] interlayer provided significant increased post-breakage strength compared to the laminate with PVB interlayer.
- Fully tempered monolithic glass provides no residual barrier on impact breakage.
- Applied PET film does not retain the glass in place on breakage.
- PVB laminates remain attached to the system on impact breakage. However, PVB laminates display no residual barrier after glass breakage.
- Laminates with SentryGlas® do display a residual barrier after glass breakage. The 0.89 mm (35 mil) SentryGlas® demonstrates considerable post-glass breakage integrity. The 1.52 mm (60 mil) SentryGlas® allows a reduction in glass thickness, with good barrier performance.

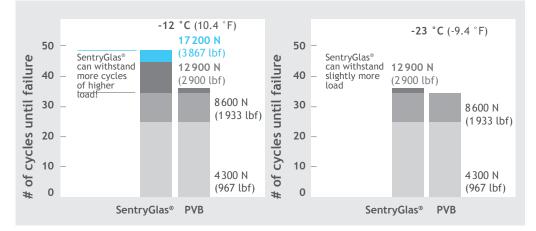
TOUGHNESS PERFORMANCE EVALUATION

The results demonstrate the good toughness of SentryGlas[®] interlayer even at low temperatures. At -12 $^{\circ}$ C (10.4 $^{\circ}$ F), compared to

PVB, SentryGlas[®] interlayer withstood more cycles of higher load. At -23 °C (-9.4 °F), SentryGlas[®] withstood slightly higher load.

In toughness tests conducted in DuPont laboratories, laminates with SentryGlas® were compared with PVB laminates.Laminates with SentryGlas® showed excellent performance over a broad temperature range. Both types of laminates were tested by applying an increasing load until the glass broke. How many load sequences it took until glass breakage were recorded. See test graphics below.
